1579 Sample Street , CA
Inspection prepared for: Sample Client
Date of Inspection: 5/12/2021

Inspector: Scott Schildknecht
ASHI Certification # 252268
1485 Maria Avenue , Concord , CA 94518
Phone: (707)649-8700
Email: scott@northbayinspection.com
Northbayinspection.com

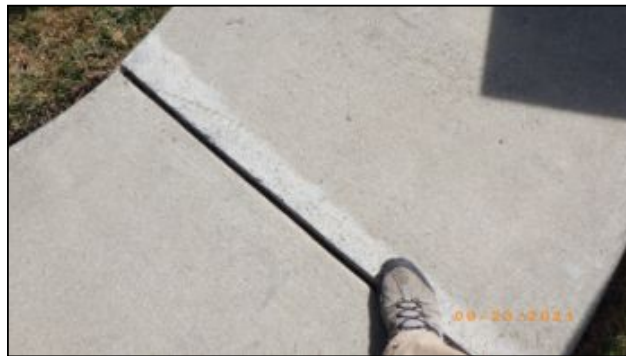
There are one or more trip hazards around this home. We advise that these areas be well lit at night. We also recommend making appropriate changes to the walking surfaces to reduce trip hazards.

trip hazard

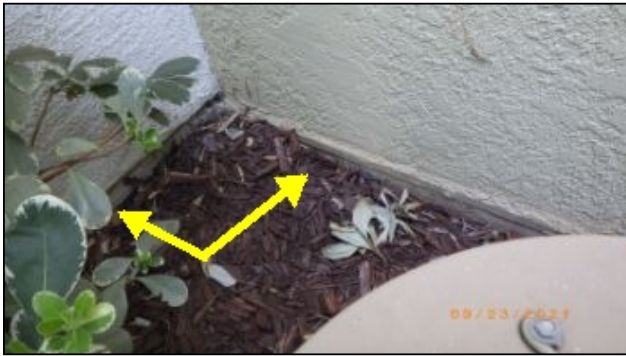
There is insufficient clearance between the exterior siding components and grade. There should be six inches of clearance from soils and a minimum of two inches from concrete flatwork to minimize damage caused by rainwater splashing against the house and to make it easier to spot activity by wood-destroying insects. We recommend adjusting the exterior grading where necessary to achieve this clearance.

improve ground clearance

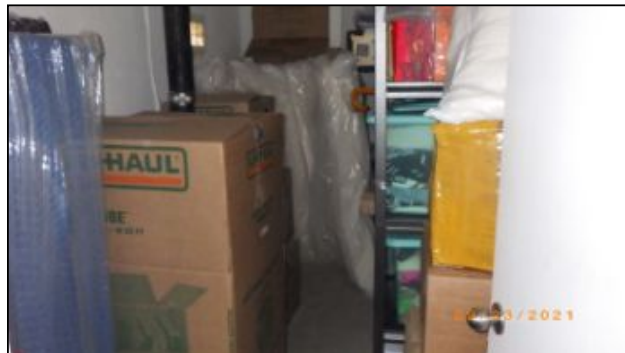
This basement and or subarea is below the soil grade level and could be subject to moisture/water intrusion. There were no obvious indications of ground water in the basement at the time of this inspection. We recommend asking the owner about the history of this area and if there have been any water, moisture, or humidity related problems. Note: This inspector cannot verify if this area has proper moisture barriers and drainage. It is beyond the scope of this inspection to water test or perform destructive testing. For further information about this basement an experienced waterproofing contractor should be consulted.

below grade\limited access

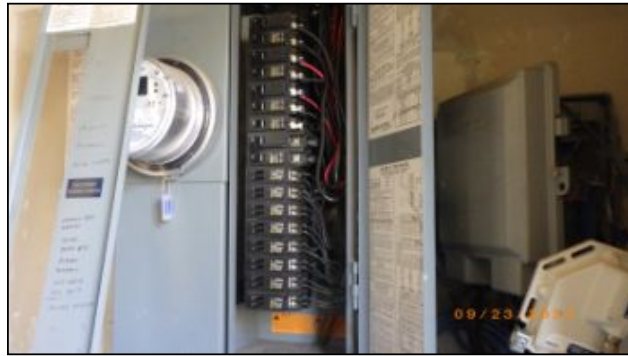
The installation of the main electrical panel appears to have been completed by qualified personnel. A comprehensive analysis of the electrical system is a specialized and lengthy process that exceeds the scope of a standard general building inspection. If further examination of the system is desired, the reader is referred to the services of a certified electrician or electrical engineer.

The main panel appears to have room for future upgrades or additions to the system. For more information we recommend further evaluation by a qualified electrician.

main panel ok

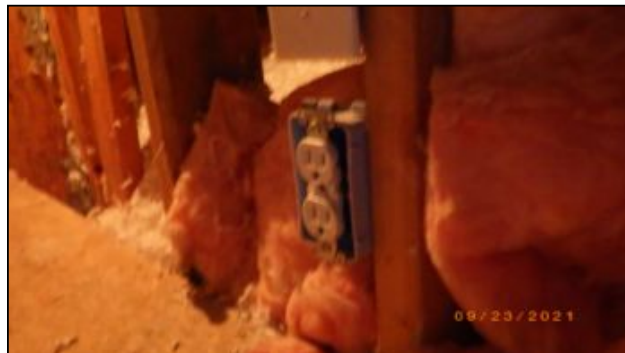
We found that at least one outlet is missing a cover in the attic of the home. It is possible for persons to come in contact with energized components - a significant safety hazard. To achieve the intended level of safety we recommend all missing covers be immediately installed.

missing cover

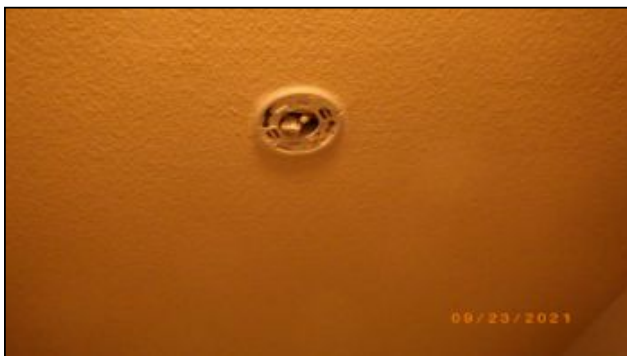
Although this home has some smoke alarms we recommend installing more. To bring the home up to modern standards: One in each bedroom (sleeping room), in common hallways adjacent to sleeping rooms, and at least one on each level of the home. It is a standard recommendation that smoke alarms are located where they will not be triggered by steam and/or fumes from bathrooms or kitchens. Note: Many municipalities now require that older homes must be upgraded to meet modern smoke alarm codes upon sale of the property and we recommend the installation of at least one photo electric type detector in this home.

missing smoke detector

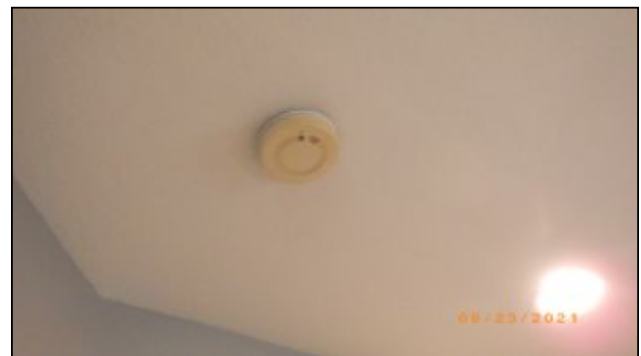
One or more smoke detectors in this home are older (more than 10 years) The life expectancy of smoke alarms is generally 10 years, after which point their sensors can begin to lose sensitivity. The test button only confirms that the battery, electronics, and alert system are working; it doesn't mean that the smoke sensor is working. We recommend replacing them with new models. Note: Many municipalities now require that older homes must be upgraded to meet modern smoke alarm codes upon sale of the property including upgrading to have batteries that last at least 10 years.

old smoke detectors

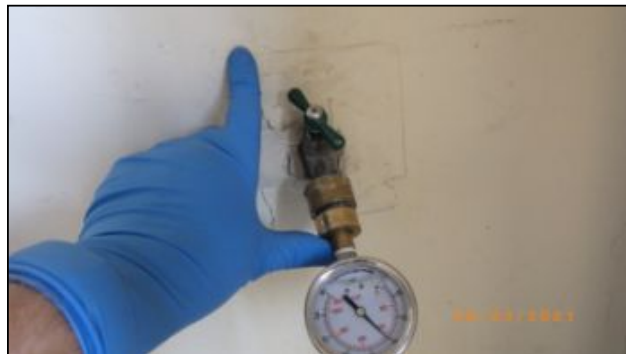
The hose bib (faucet) is loose in the garage. Loose pipes and hose bibs can break causing significant water related damage. We recommend having a qualified handy person or plumber properly securing all loose hose bibs.

loose hose bib

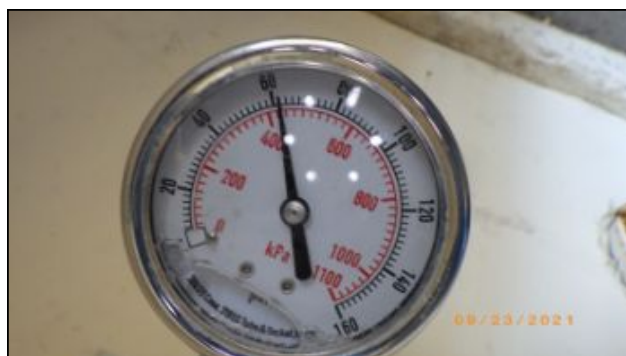
Note: Water pressure between 45 and 65 PSI is considered normal. Pressure in excess of about 80 PSI is considered excessive.

water pressure 62 PSI

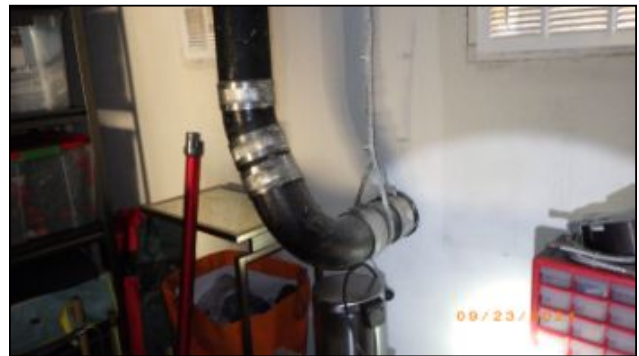
This building has cast iron waste lines. Cast iron waste plumbing has been the traditional industry standard in residential housing for nearly a century and has a typical service life of 40+ years.

cast iron waste lines

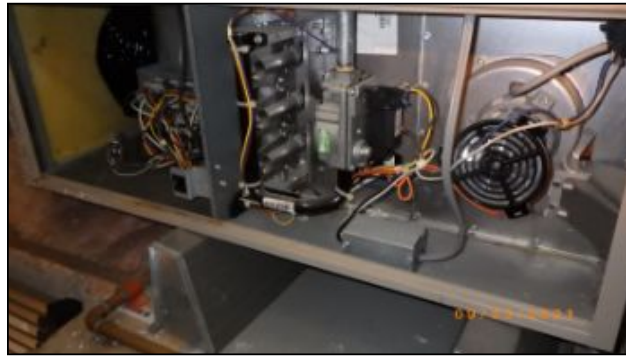
generally worn

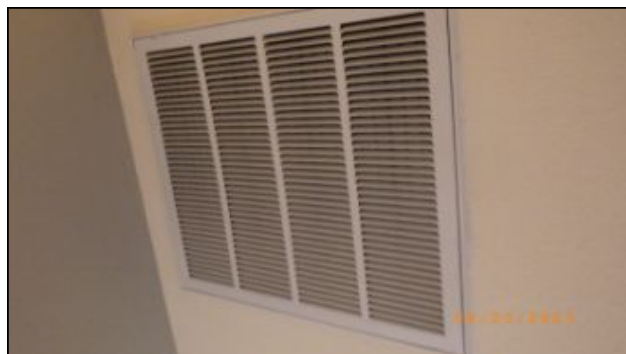
The furnace filter is dirty and should be replaced now. A dirty filter will reduce the efficiency and service life of the furnace.

dirty filter

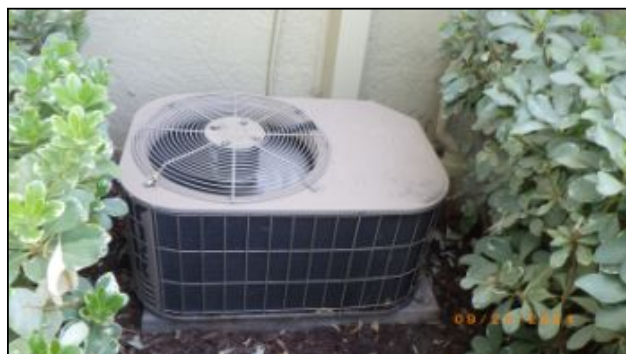
The air conditioning compressor appears to be worn and original to the home and could be nearing the end of its expected service life. Although this unit may function normally we recommend having it serviced and evaluated by a HVAC contractor.

generally worn

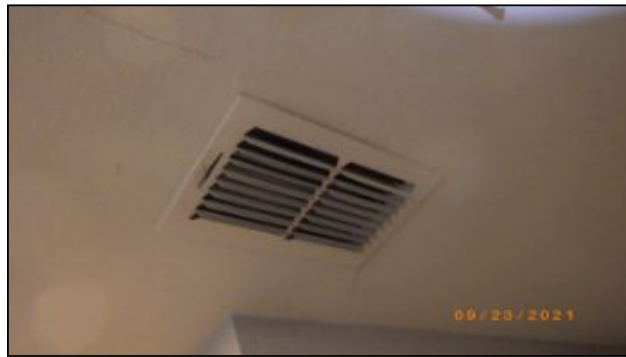
There are cracks in the interior wall/ceiling surfaces that we believe are the result of structural movement caused by settling. The cracks are unsightly and should be repaired. This inspector does not anticipate any rapid changes barring sudden impacts (construction, earthquakes, etc.). Please read the structural section of this report carefully for more information about settlement.

typical settlement cracks

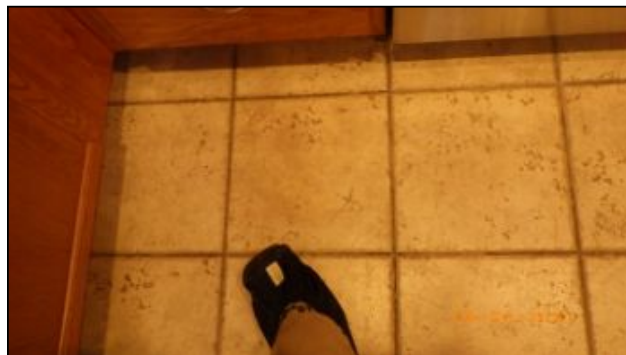
Some tiles on the floor in the kitchen are cracked. The exact cause of the crack(s) are unknown but likely due to one or more factors including but not limited to: Typical framing/foundation movement over time, heavy items dropped on the tile, improper support framing, improper underlayment, seismic activity, or even faulty materials. This inspector does not anticipate any rapid changes. We recommend monitoring this area for changes. For more information a specialized tile contractor should perform further evaluation and possible repairs. Note: Any visible structural defects will be noted in the framing or foundation sections of this report.

cracked tile

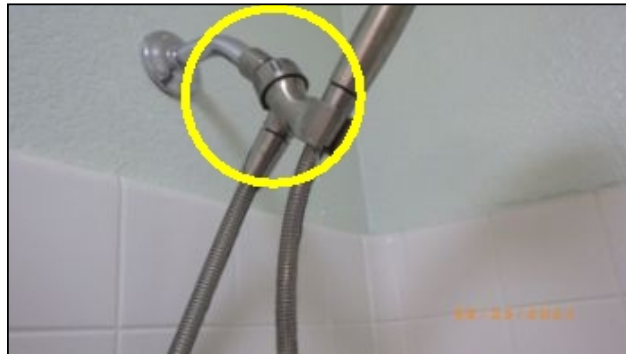
The shower head in the upstairs hallway bathroom leaks and should be repaired. Water spraying on the wall or on the floor is a primary cause of future moisture related damage. Note: Simply applying Teflon tape to the threads of the shower head/arm and properly tightening the various nuts will often stop the leak(s).

leaking shower head

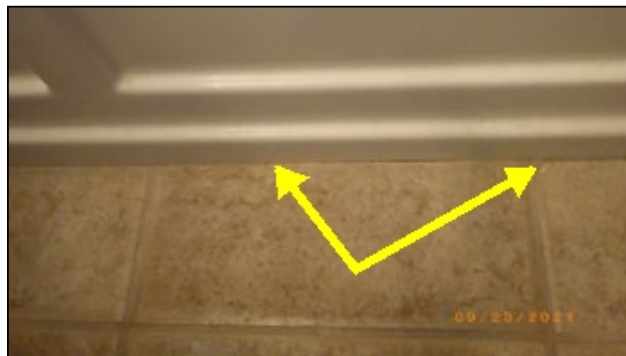
In the master bathroom there are some gaps between the tub/shower and the flooring. These voids can allow water to damage the wood subfloor below. As a part of this homes routine maintenance we recommend checking these areas for softness (damage) and keeping these joints well sealed.

needs sealing

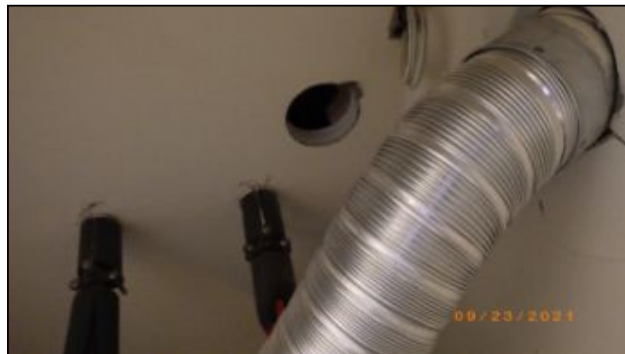
There are holes or voids in the garage ceiling and/or walls. These sheetrocked walls/ceilings are intended to slow a fire from entering the living space and allow more time for occupants to escape. Holes or voids in these surfaces significantly reduce the intended fire protection for this home. We recommend properly repairing/sealing all holes in the walls or ceiling in the garage.

holes in firewall

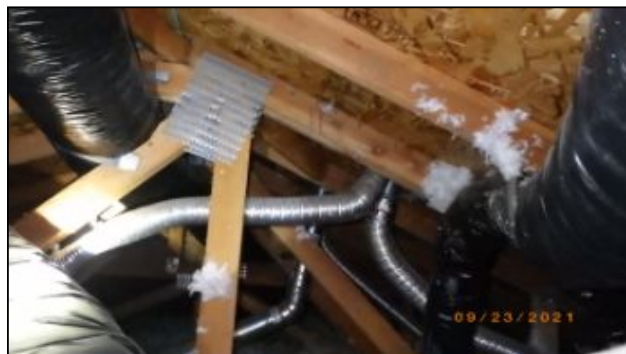
The visually accessible areas of the attics framing appeared normal with no obvious defects.

visible areas ok
