1234 sample street , CA
Inspection prepared for: Sample Client
Date of Inspection: 4/3/2022

Inspector: Scott Schildknecht
ASHI Certification # 252268
1485 Maria Avenue , Concord , CA 94518
Phone: (707)649-8700
Email: scott@northbayinspection.com
Northbayinspection.com

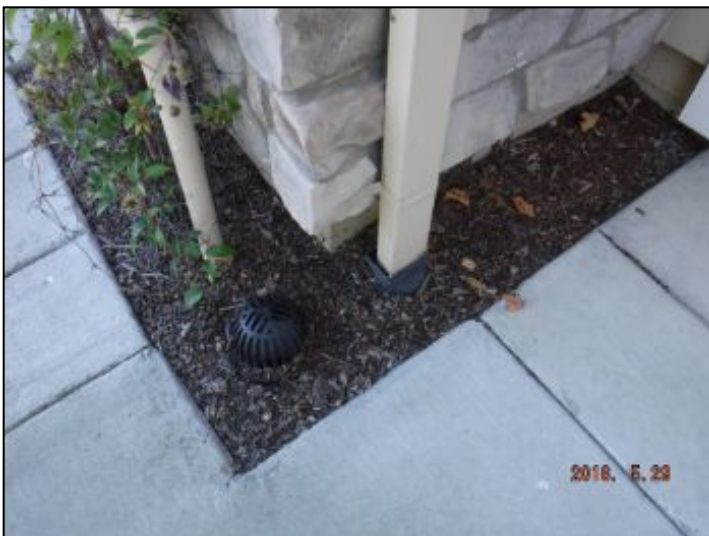
- This property has dedicated drains for the roof drainage system. These drains can be effective in reducing ponding and controlling surface water and runoff. It is not uncommon to have these drains fill with debris and become ineffective. We recommend that all surface drains be tested periodically by using a garden hose and check the low point or discharge termination. Some systems have separate systems for the downspouts and surface drains, however most systems are dual function. It is important to check this system every fall. Excess water near the perimeter of the home can adversely affect the foundation.

dedicated drains

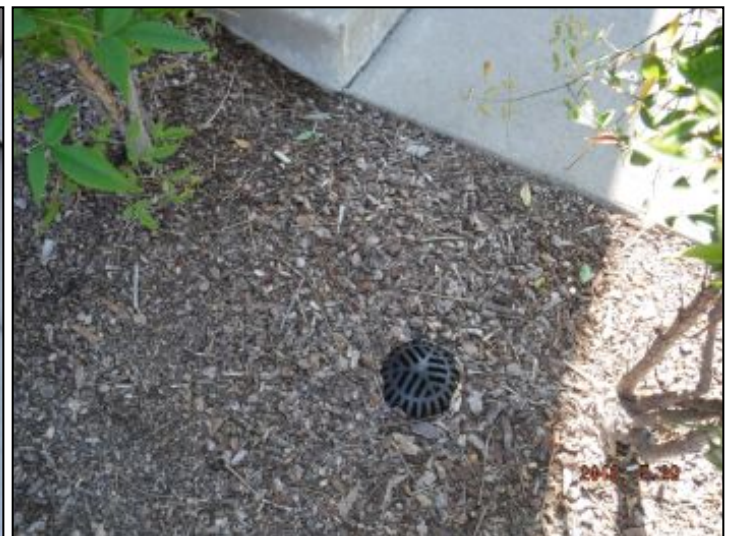
- This home has surface drains. These drains can be effective in reducing ponding and controlling surface water and runoff. It is not uncommon to have catch basins fill with debris and become ineffective. We recommend that all surface drains be tested periodically by using a garden hose and check the low point or discharge termination. Some systems have separate systems for the downspouts and surface drains, however most systems are dual function. It is important to check this system every fall. Excess water near the perimeter of the home can adversely affect the foundation.

has surface drains

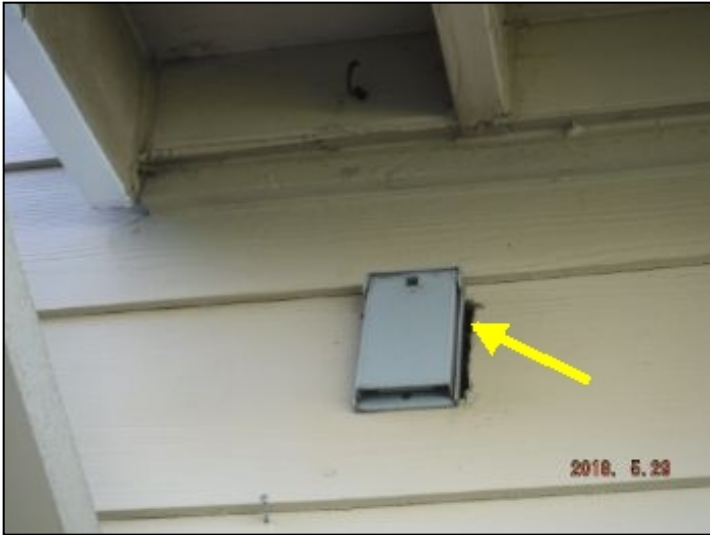
- The siding is loose or has gaps on the front and right side side. Loose siding can allow water and insect entry. We recommend securing any loose siding components and sealing it with an appropriate high quality caulking.

gaps at siding

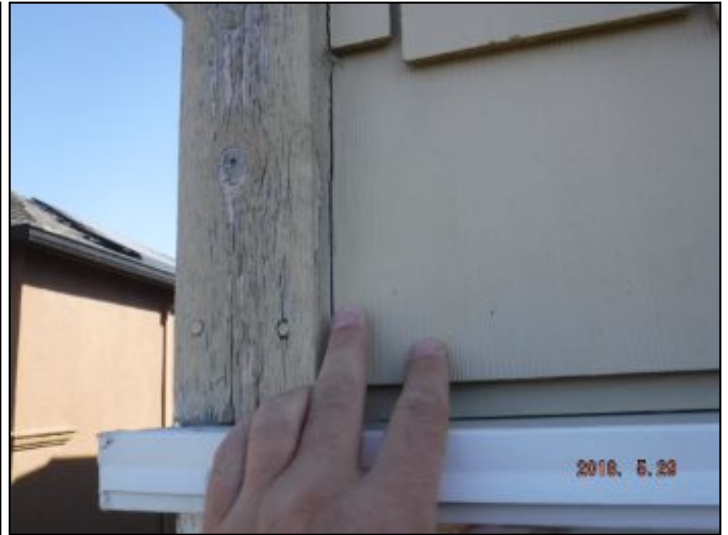
gaps at trim and siding

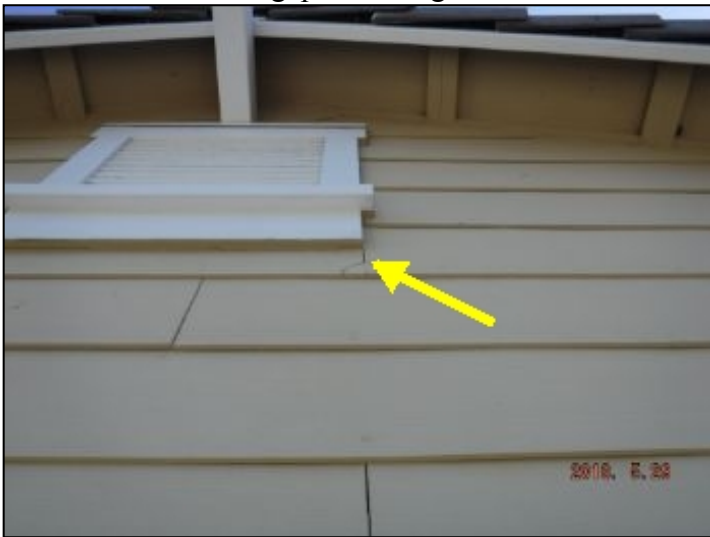
- There are holes, voids or damage to the exterior cladding of this home at the left side. These holes can allow water, insect or animal entry into the framing or home. We recommend having a qualified contractor provide further evaluation and cost estimates for all appropriate repair.

cracked siding

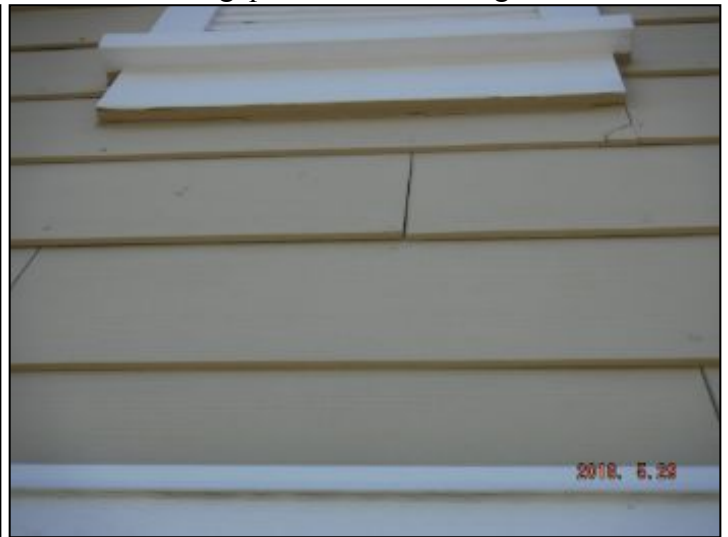
loose siding

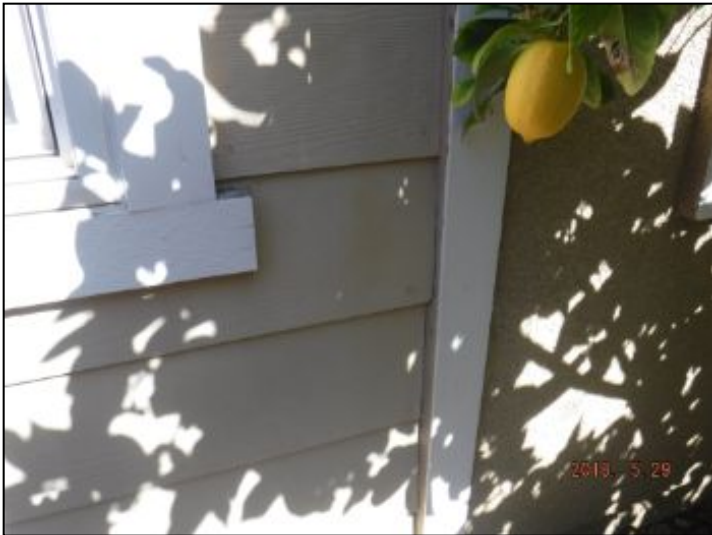
loose siding

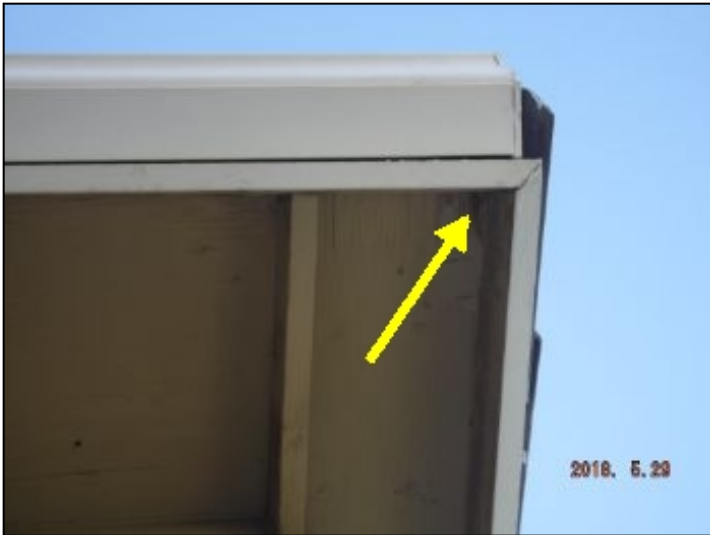
moisture damage

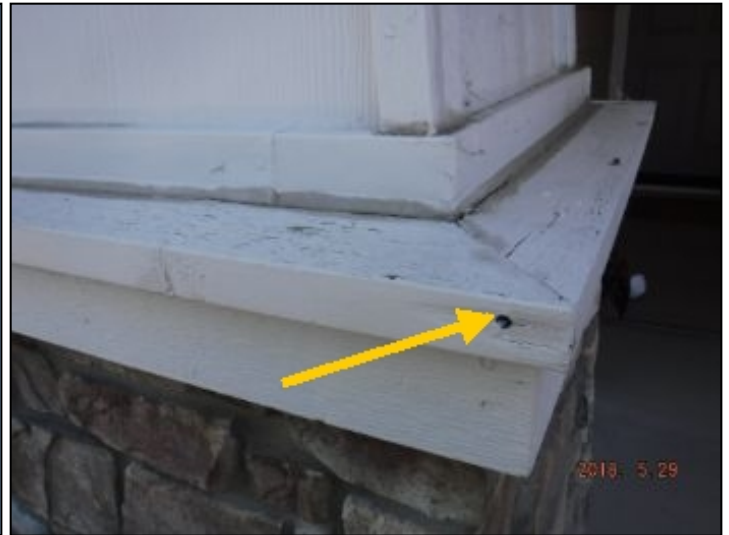
moisture damage

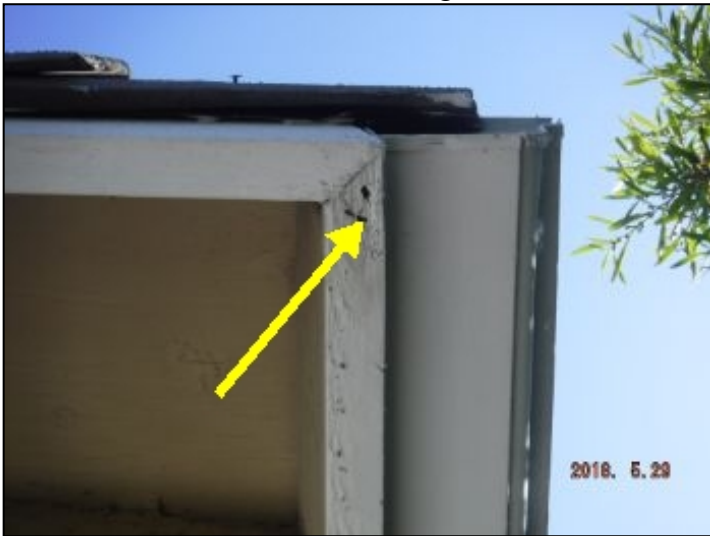
moisture damage

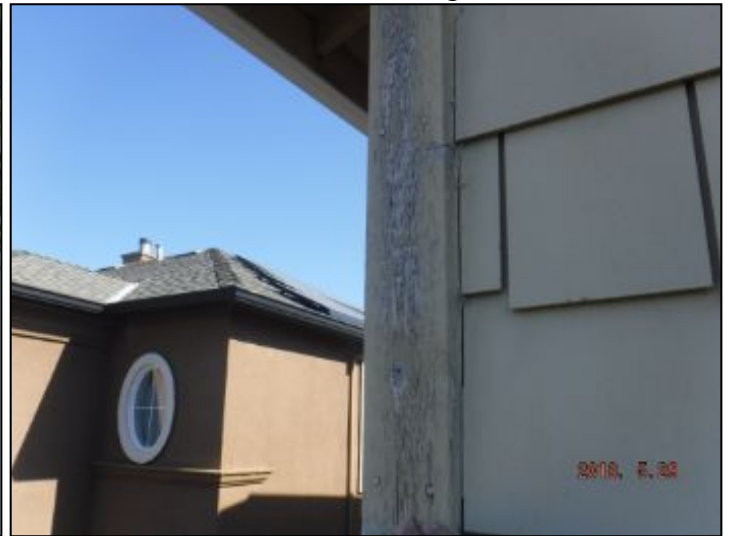
- There is weathered, faded, cracked or blistering paint on this home at several places on the trim components. Paint is not only important to the appearance of the house, it protects wood siding and trim from weather damage. We recommend having the home touched up or repainted as necessary.

peeling paint

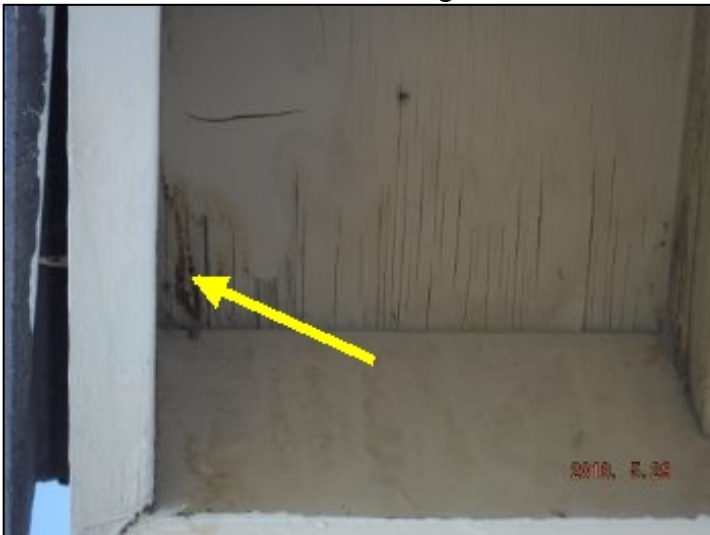
moisture damage

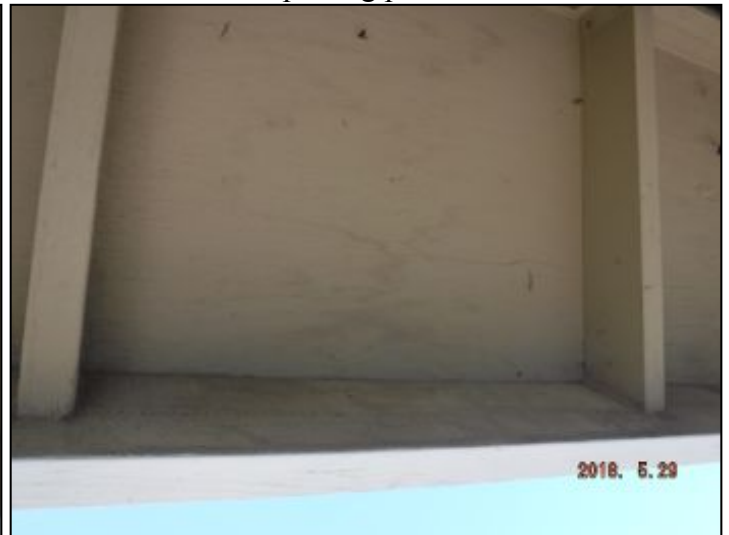
water stains

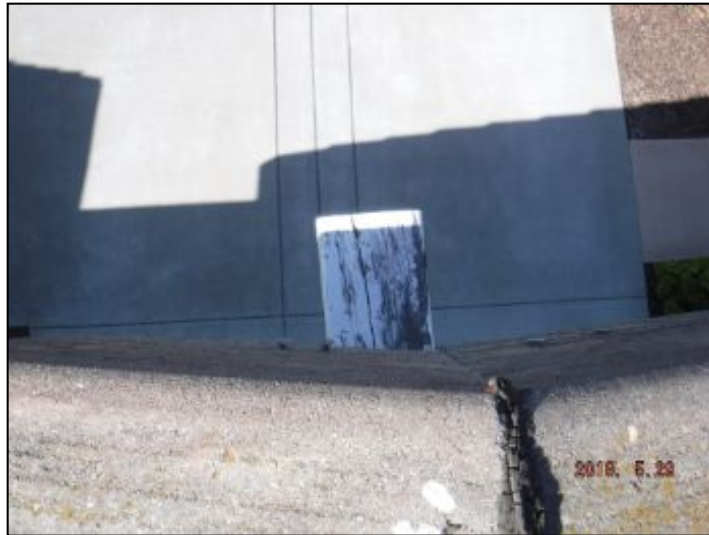
- There are exposed beam(s) end(s). Wood beams and rafter tails that protrude beyond the eaves are exposed to harsh weather and therefore prone to moisture related damage. To prevent future damage on exposed beam it is worthwhile and relatively inexpensive upgrade to have sheet metal caps installed on the tops of these beams.

exposed beams (ok)

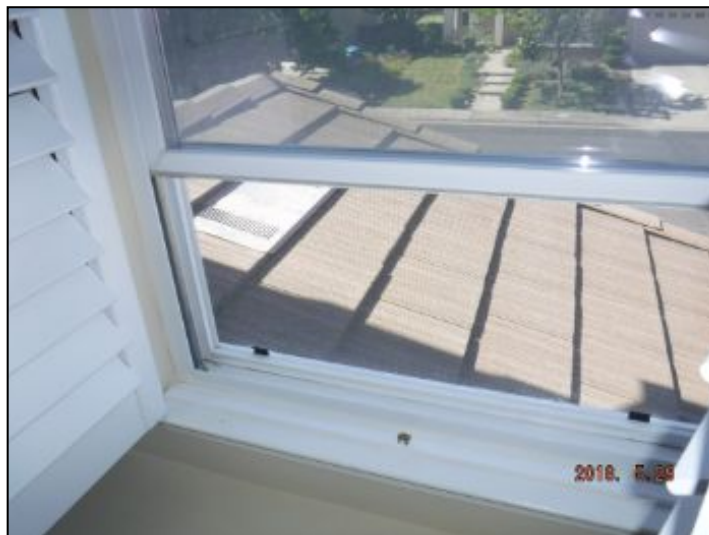
- At least one window at the 1st bedroom upstairs has a damaged spring or cord. This can be a potential hazard as the window does not stay open and could crash down on a person causing injury. This window would benefit from adjustment/repair by a qualified carpenter or window specialist.(Note) Only a representative number of windows were tested as per ASHI standards. We recommend testing all window in this home for proper operation.

damaged spring

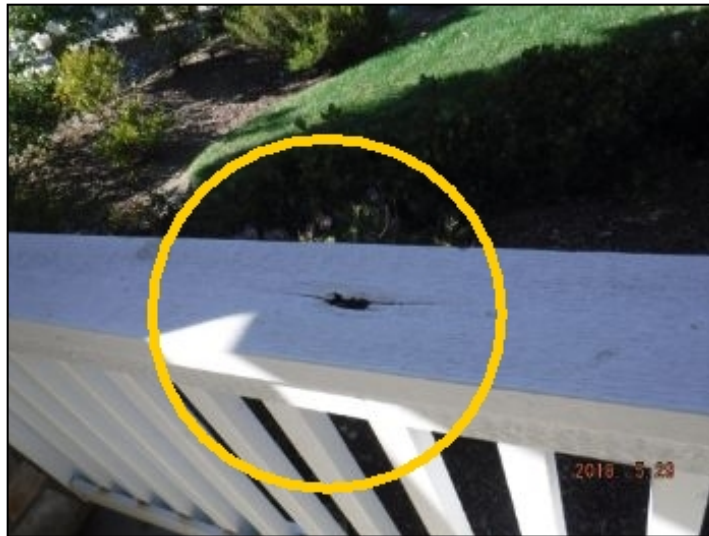
- The handrail/ guardrail at the front porch is moisture fungus damaged. We recommend further inspection by a licensed class three structural pest control firm.

moisture damage

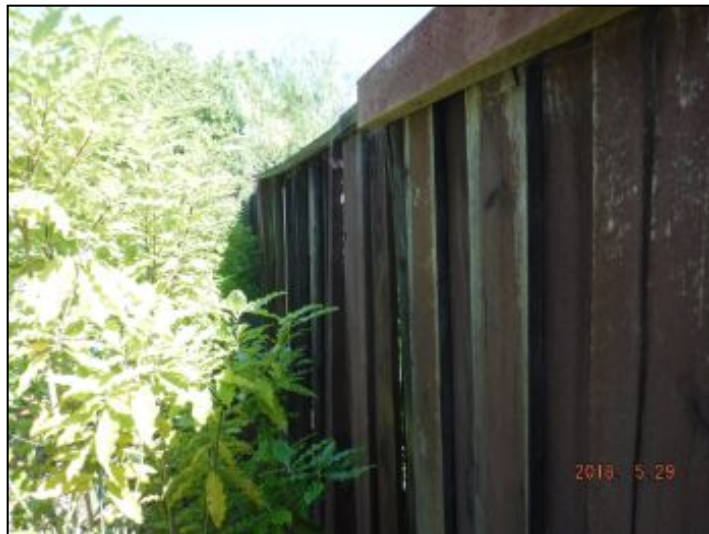
- The fence leans and/or is loose at the rear of the property. The fence post(s) may be broken or rotten at the base. We recommend further evaluation and repair by a qualified handyperson or contractor.

loose fence

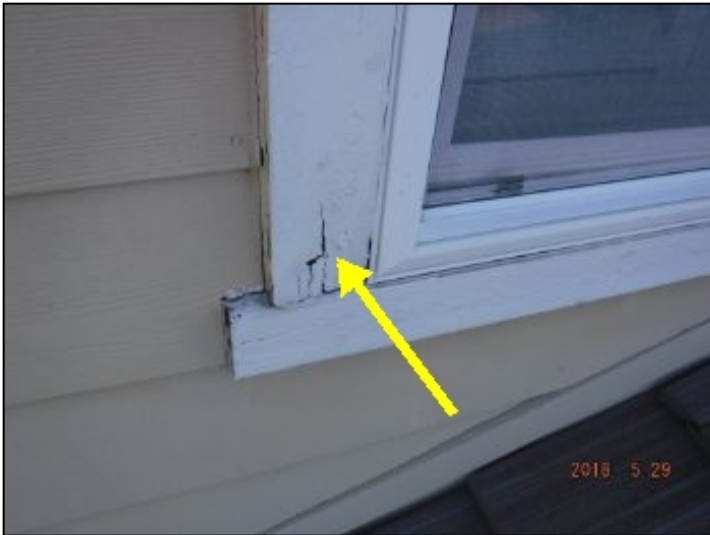
moisture damage

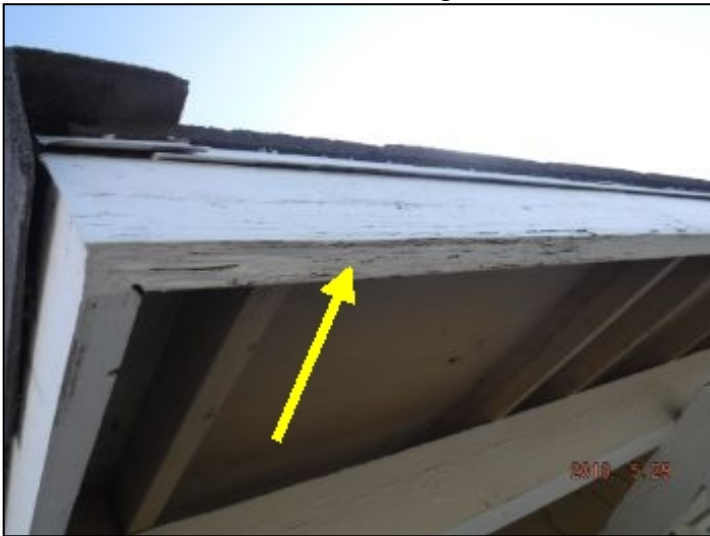
moisture damage

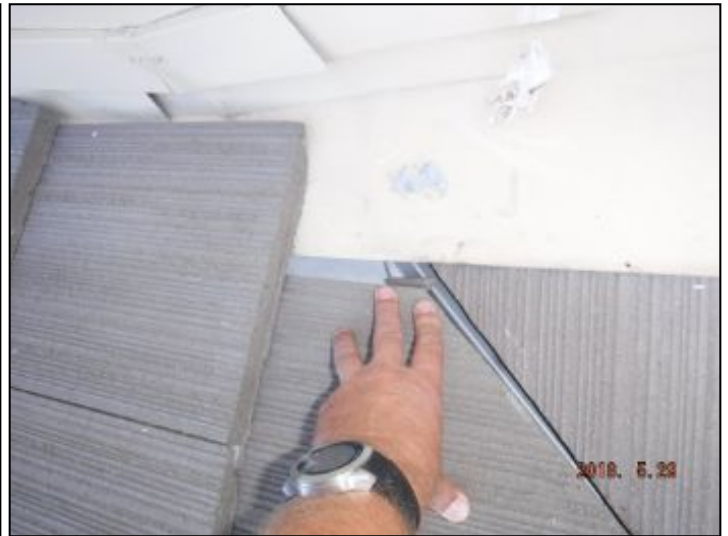
- There are some loose tiles on this roof. Loose tiles can slip out of place improperly exposing the waterproof membrane below and potentially fall causing property damage or injury to persons below. We recommend having a qualified roofing contractor check this roof for loose tiles and make the appropriate repairs.
- There is some moisture/ fungus damaged (dry rot) to some window trim and fascia boards visible from the roof. We recommend repairs and further evaluation by a qualified contractor and/ or pest firm. Note: Often this area will not be in the scope of a standard pest inspection as they normally will not inspect from the roof unless specifically arranged.

loose tiles

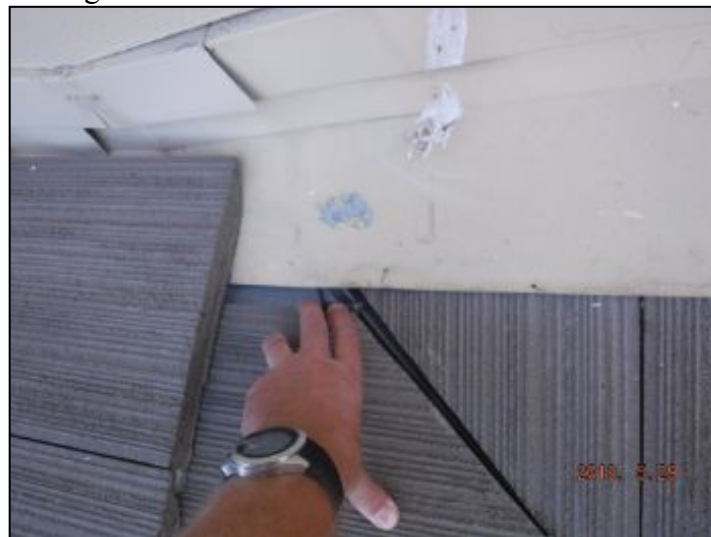
loose tiles

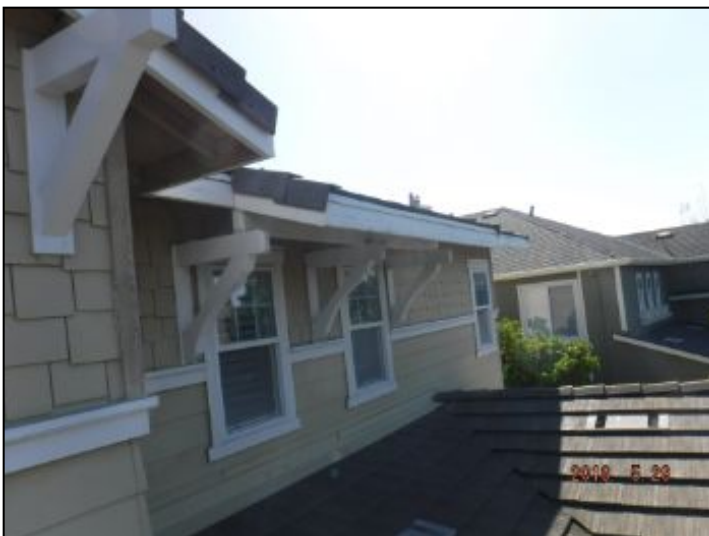
- This home does not have gutters at the front second story. We recommend that a qualified contractor install gutters and downspouts where they are missing.

missing gutters

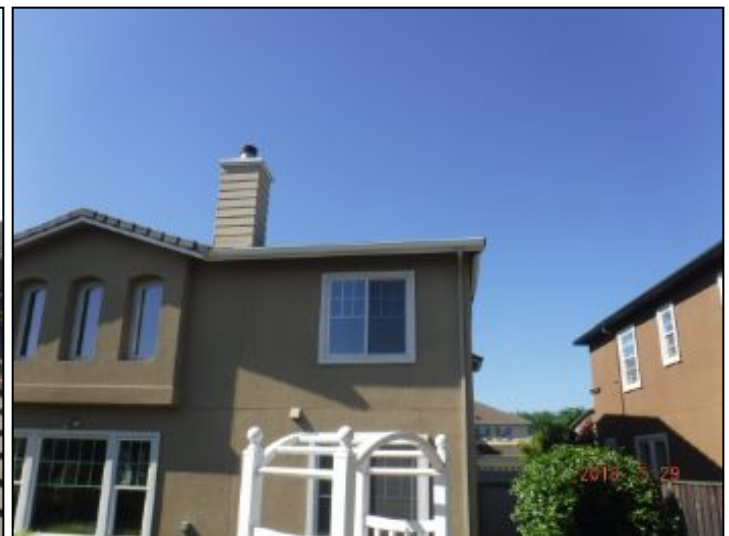
gutter slope poor

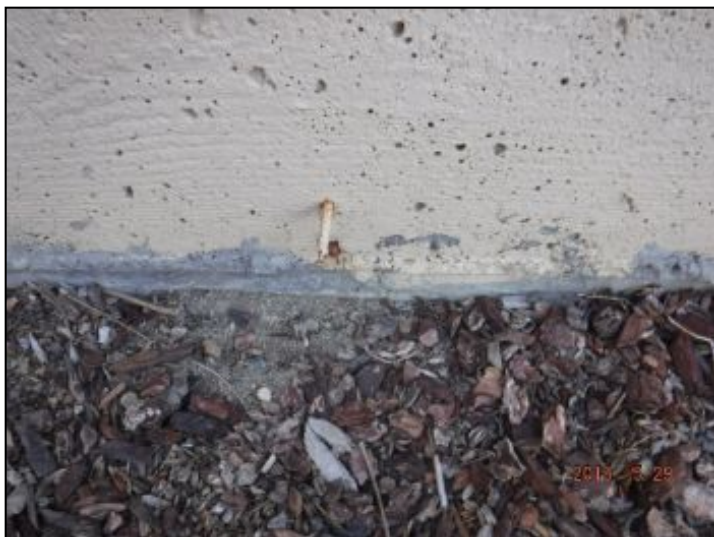
nails sticking out

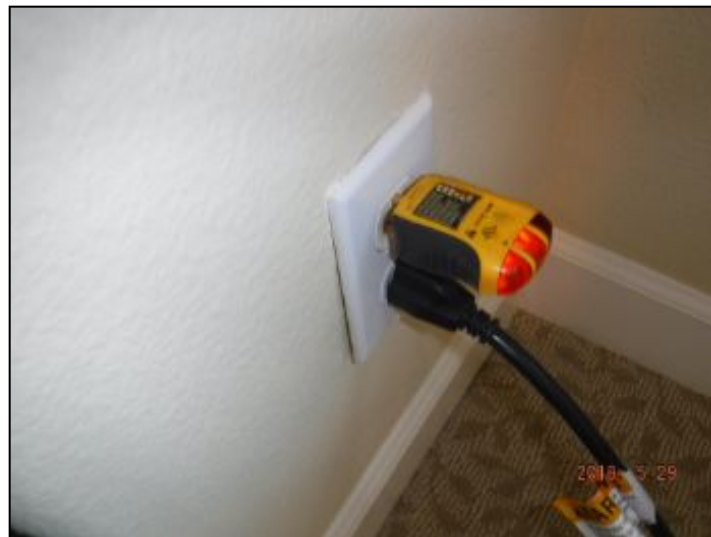
- **There is at least one loose outlet in the office. Loose or improperly secured outlets are a potential fire and safety hazard. We recommend that a qualified electrician perform further evaluations and repairs.**

loose outlet

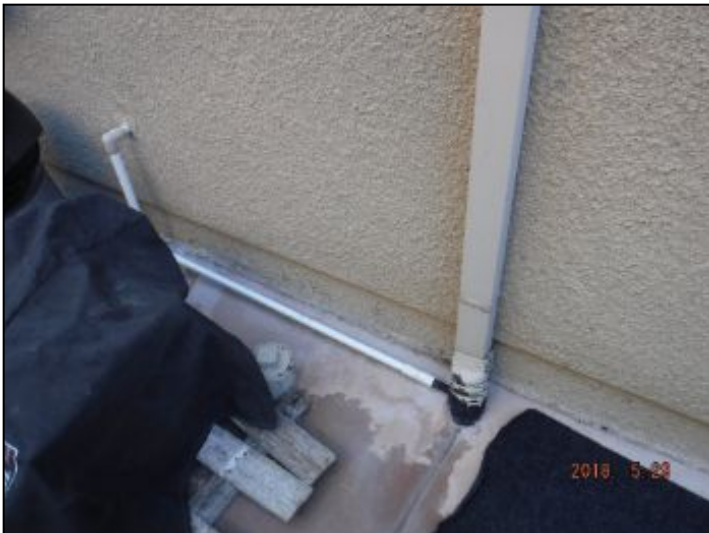
abandoned plumbing

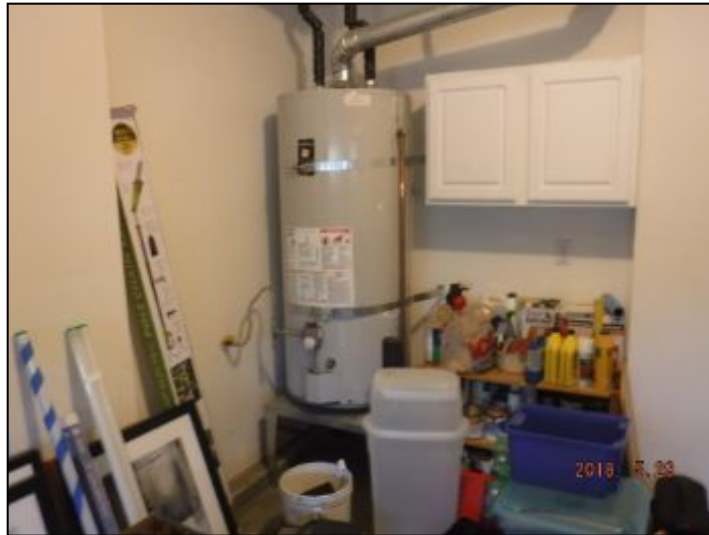
generally worn

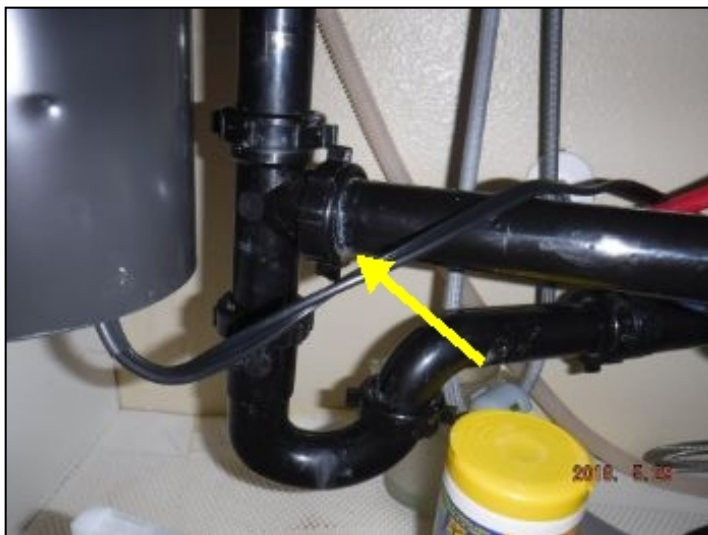
- There is a drain line leak below the main kitchen sink. Plumbing leaks can cause significant water and fungus related damage. We recommend immediate evaluation and repairs by a qualified plumber.

drain leak

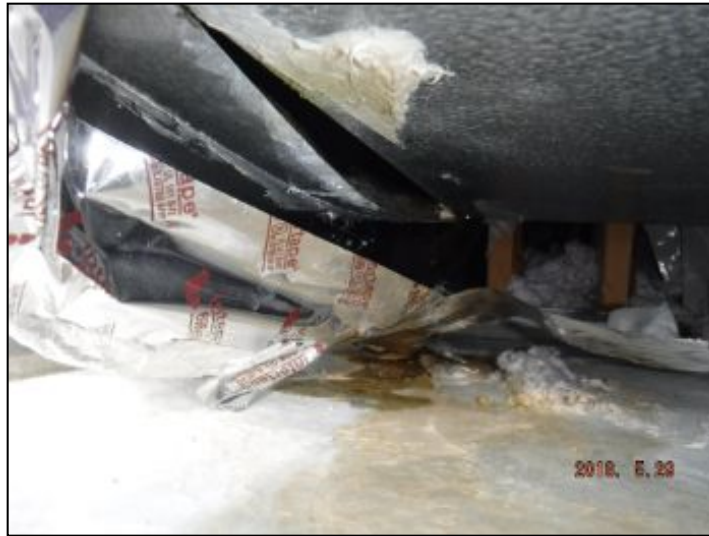
- We found leaking/disconnected heating duct(s) in the attic at the plenum. This allows conditioned air to spill out improperly and wastes fuel. Immediate correction by a qualified HVAC repair person is recommended.

leaking plenum

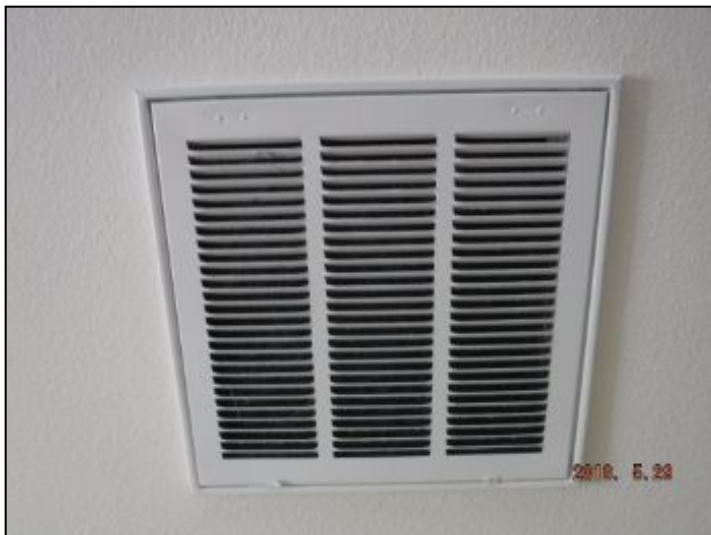
dirty filters

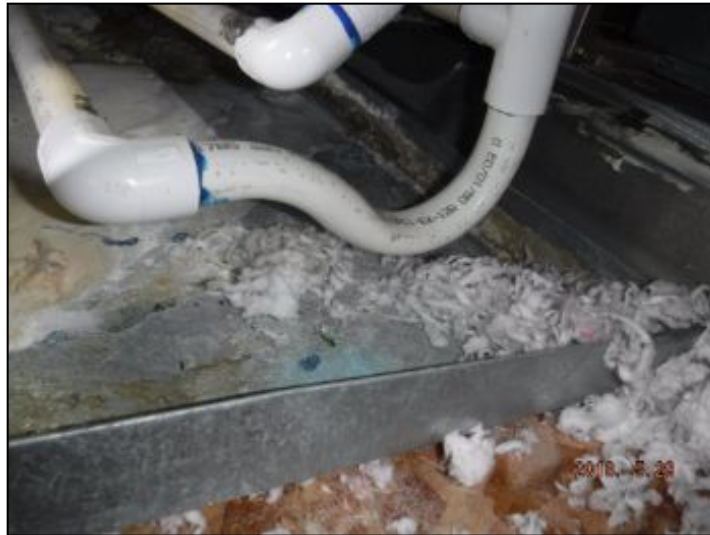
- The condensate pan at the air conditioner evaporator coil has some debris, construction materials or insulation in it. This debris can clog the condensate line and cause significant water damage to the interior of the home. We recommend clearing this pan of all debris that might cause the pan drain to clog.

debris in pan

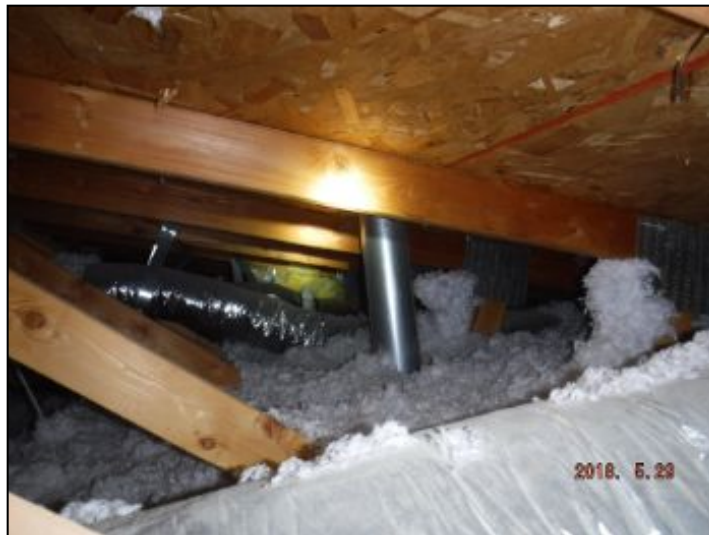
- The clothes dryer vent flows upward. This configuration can cause lint to become trapped and eventually clog. Due to the high temperatures of the dryer is a potential hazard (particularly with gas dryers). The vent appeared clogged at the time of this inspection. We recommend immediately having a qualified handyperson or handyperson clear and check this vent for proper flow. Note: This pipe should not exceed about 15 feet in length, have minimal bends/turns and terminate at the exterior of the home with either a flapper or a screen to prevent animal entry.

flows up dirty

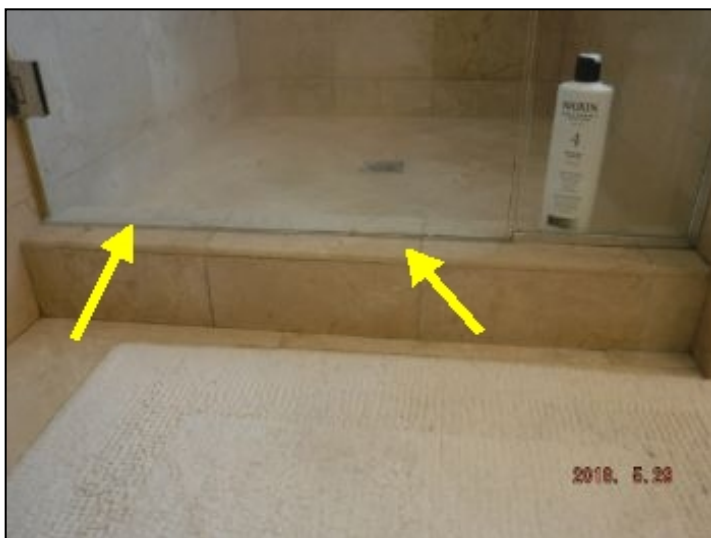
- The shower door lower seal "wipe" is missing or damaged in the master bathroom. This condition can allow water to reach the floor potentially causing moisture related damage over time. We recommend having a qualified Glazer or other contractor provide further evaluations and repairs of this shower door. Note: These are normally a flexible flap that attaches to the bottom of the shower door with glue, in a track or possible with screws. After proper installation the door should close easily without binding.

missing wiper seal

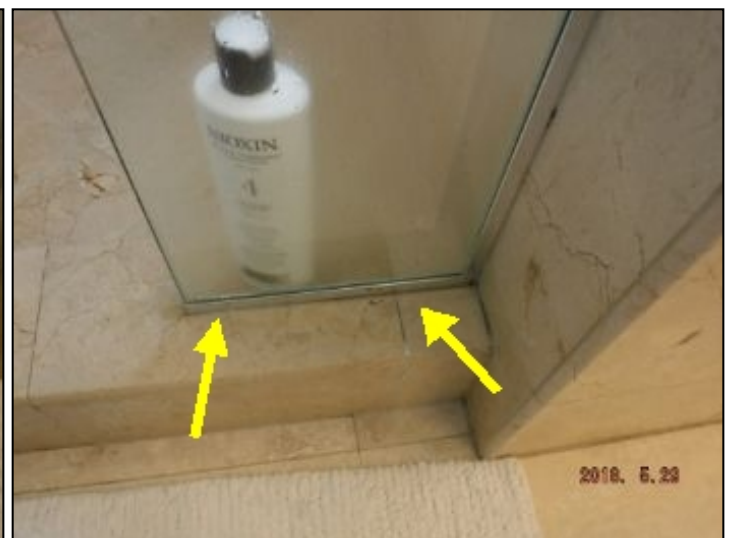
leaking enclosure

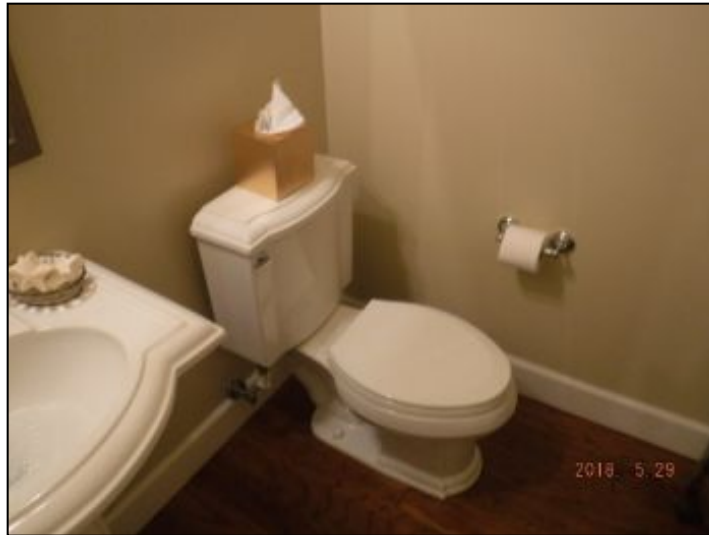
- The toilet(s) were checked and they functioned normally.
- The toilet in the half bathroom is loose at the floor. Loose toilet pedestals can ruin the wax seal between the pedestal and the soil pipe, resulting in leaks and often rotting flooring beneath the toilet. We recommend having the pedestal tightened up. The client should note that the movement of this pedestal might have already damaged the seal, so we recommend replacing the seal as well. The whole process, removing the toilet to replace the seal and reinstalling the toilet, will take the average professional less than an hour.

loose toilet

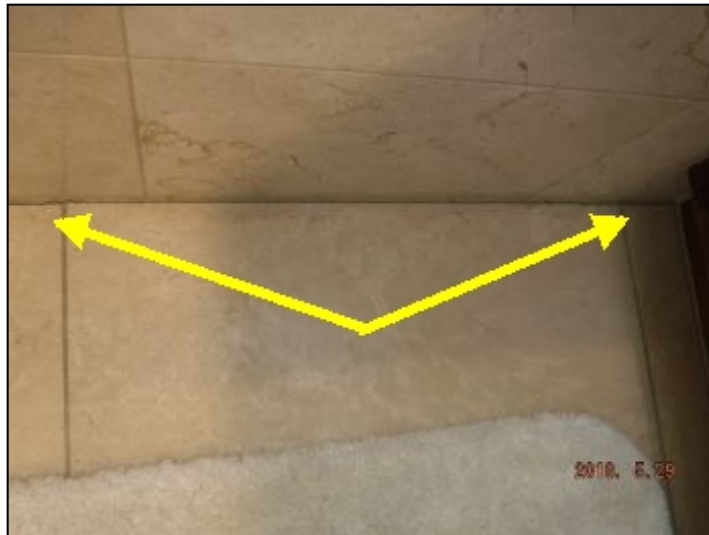
- There is tile or stone tile covering one or more bathroom floors in this home. Tile floors are water resistant but not waterproof. It is beyond our scope of inspection to remove tile (or insulation in sub area) to observe the sub-floor/ underlayment. It is possible for damage to exist below these tile surfaces that are not visible for a standard home inspection. We recommend having a qualified pest inspection firm perform further evaluations. Note: We recommend to consider using an approved grout sealing product to improve water resistance, particularly near showers.
- In the master bathroom there are some gaps between the tub deck and the flooring. These voids can allow water to damage the wood sub-floor below. As a part of this home's routine maintenance we recommend checking these areas for softness (damage) and keeping these joints well sealed.

needs sealing

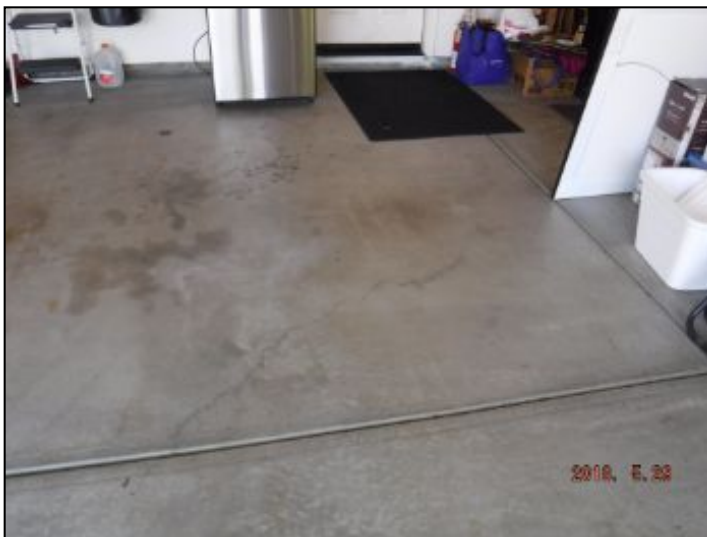
- There are several very small typical settlement cracks and or curing cracks visible on the garage floor. It is not unusual for concrete garage floors even in newer homes to have very small cracks. These are often simply the result of the concrete fully drying and curing. It is not uncommon for the cracks to open and close with the seasons as the moisture level in the soils change. Should these cracks become larger over time this could be a sign of on-going movement. This inspector does not anticipate any rapid changes in the condition of this floor.

typical cracks

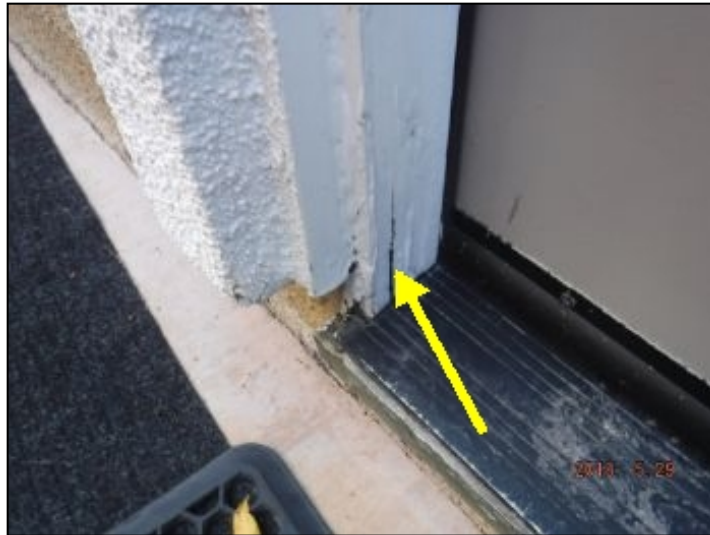
- The pedestrian access door and or door jamb to this garage at the left side is moisture damaged. We recommend further inspection by a licensed class three structural pest control firm. We recommend further evaluation by a qualified pest firm.

moisture damage
