1579 Sample Street , CA
Inspection prepared for: Sample Client
Date of Inspection: 5/12/2021

Inspector: Scott Schildknecht
ASHI Certification # 252268
1485 Maria Avenue , Concord , CA 94518
Phone: (707)649-8700
Email: scott@northbayinspection.com
Northbayinspection.com

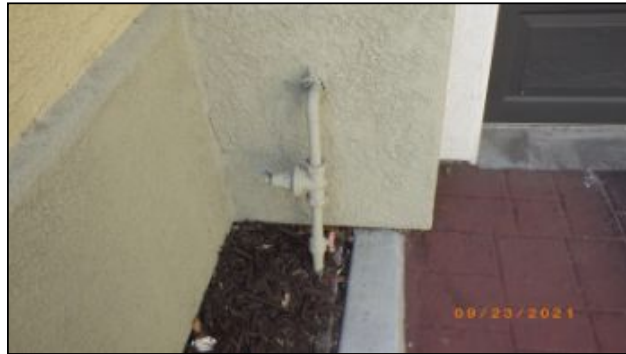
main shutoff

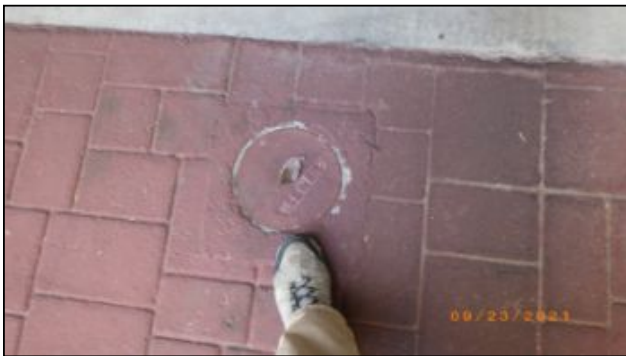
This building has cast iron waste lines. Cast iron waste plumbing has been the traditional industry standard in residential housing for nearly a century and has a typical service life of 40+ years.

sewer cleanout

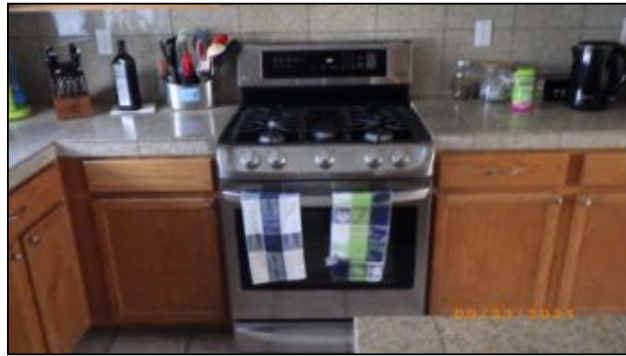
The oven and range were tested and functioned normally. It is beyond our scope of inspection to test for temperature accuracy or other functions such as self-cleaning, convection fans, timers, etc.

There is no anti-tip bracket behind/under the range/oven to prevent it tipping when the door is opened. Anti-tip devices come with new range/ovens and are supposed to be used. Without an anti-tip bracket, the stove could tip away from the wall, spilling its contents. A bracket should be added before using this oven.

tested ok

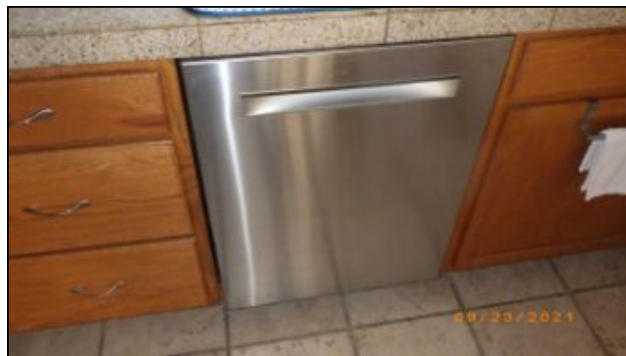
There is no air gap installed between the discharge line from the dishwasher to its waste receptacle. This is a relatively new dishwasher and some models have builtin back flow prevention devices. We recommend asking the owner for the installation instructions of this particular model to check the specifications of this particular unit. If not equipped with an air gap device older models can allow dirty contaminated water from the plumbing to be siphoned back into the dishwasher where it will contaminate the dishes. Correction will require installation of an air gap device at the kitchen sink, or wall, or necessitate looping the discharge line up over the top of the dishwasher so that it is above the flood rim of the adjacent sink and plumbing and cannot siphon waste backward. Note: Even if equipped with an internal air gap device most state residential codes require installation of this safety device.

tested ok

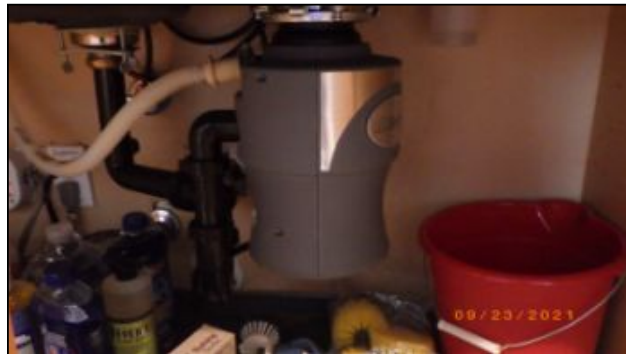
The garbage disposer is in satisfactory condition. The unit was turned on and it appeared to be functioning normally.

tested ok

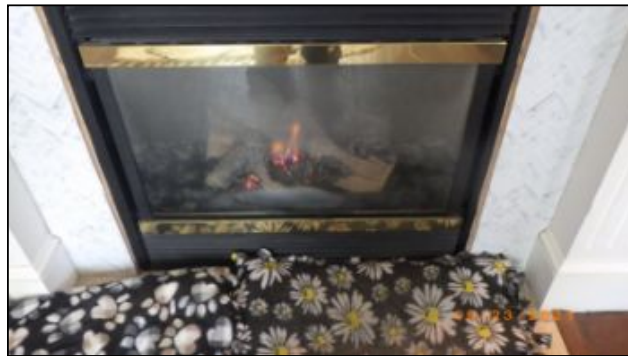
This home has fired type fireplace(s). This unit cannot burn solid fuels such as wood or presto logs. The unit was switched on and it functioned normally. The fireplace appears in generally satisfactory condition. For more information regarding maintenance and proper use of this fireplace we recommend reading the manufacturer's instructions (possibly asking seller for any literature or checking on-line).

tested ok
